Technical Report No. 64.190.14.02468.01 Rev. 00 Dated 2014-08-25

Test subject: Product: 225DM-Middle Back mesh chair

Model No.: D00225DMF001

Test specification: ANSI/BIFMA X 5.1-2011

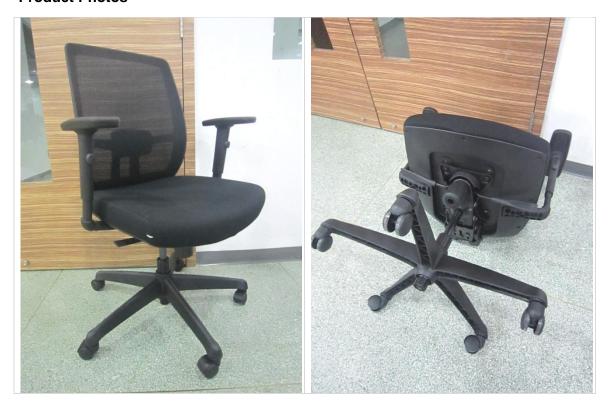
1.3 Product Photos

Chair Type: Type I and III. Height: 917~ 1005 mm

Width: 645 mm Depth: 570 mm Net weight: 16,8 kg
